# CL15-16L Safety Light Curtain User Manual

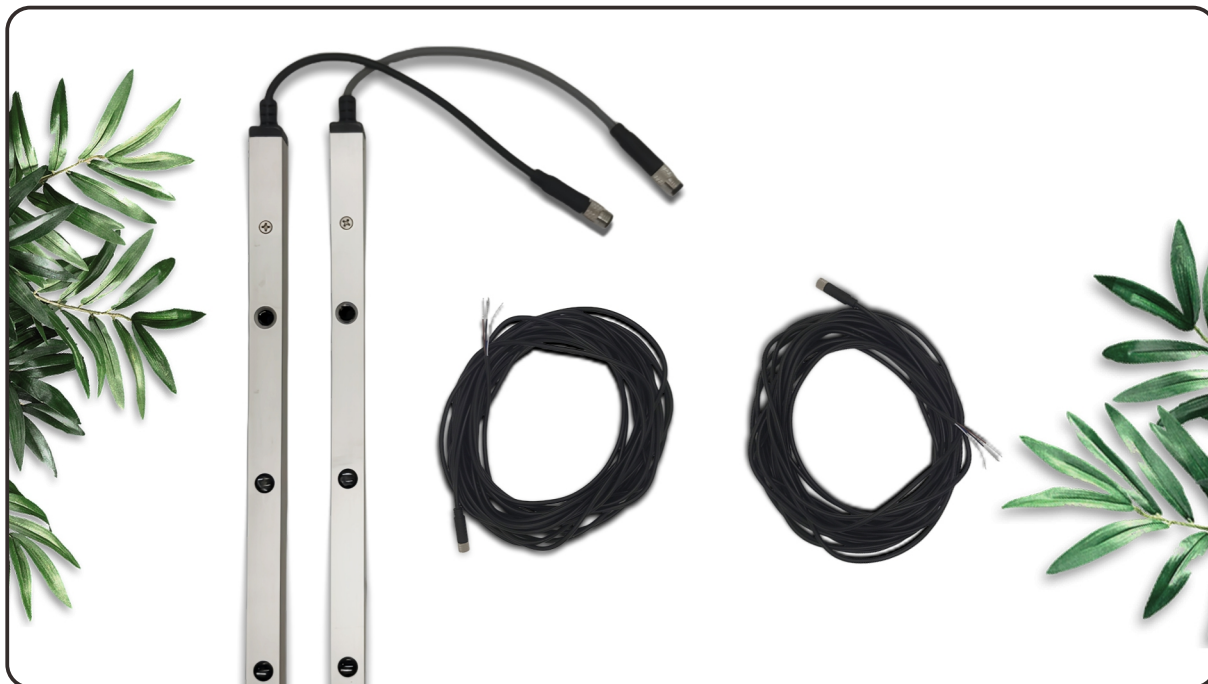
The safety light curtain creates a protective barrier by generating a beam of light between the emitter and receiver. When an object or personnel enters the grid area, the light beam is obstructed, immediately triggering the safety system to take appropriate measures. Typically installed at critical points of devices such as doors, automatic doors, lifting equipment, etc., they are positioned to promptly detect potential crushing hazards. These devices are widely utilized in industrial and commercial environments, serving as an indispensable component of automation systems, especially in situations requiring high levels of safety.

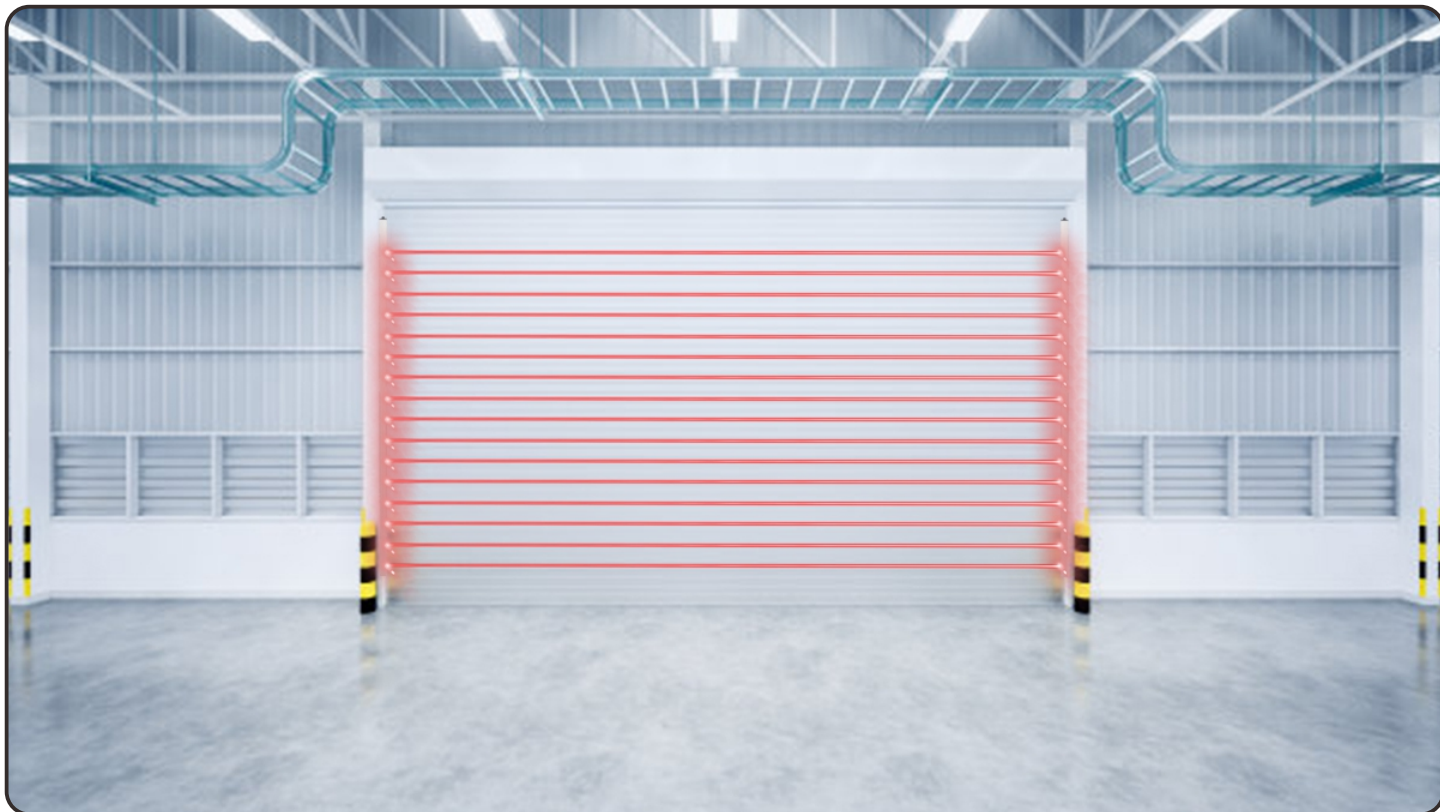
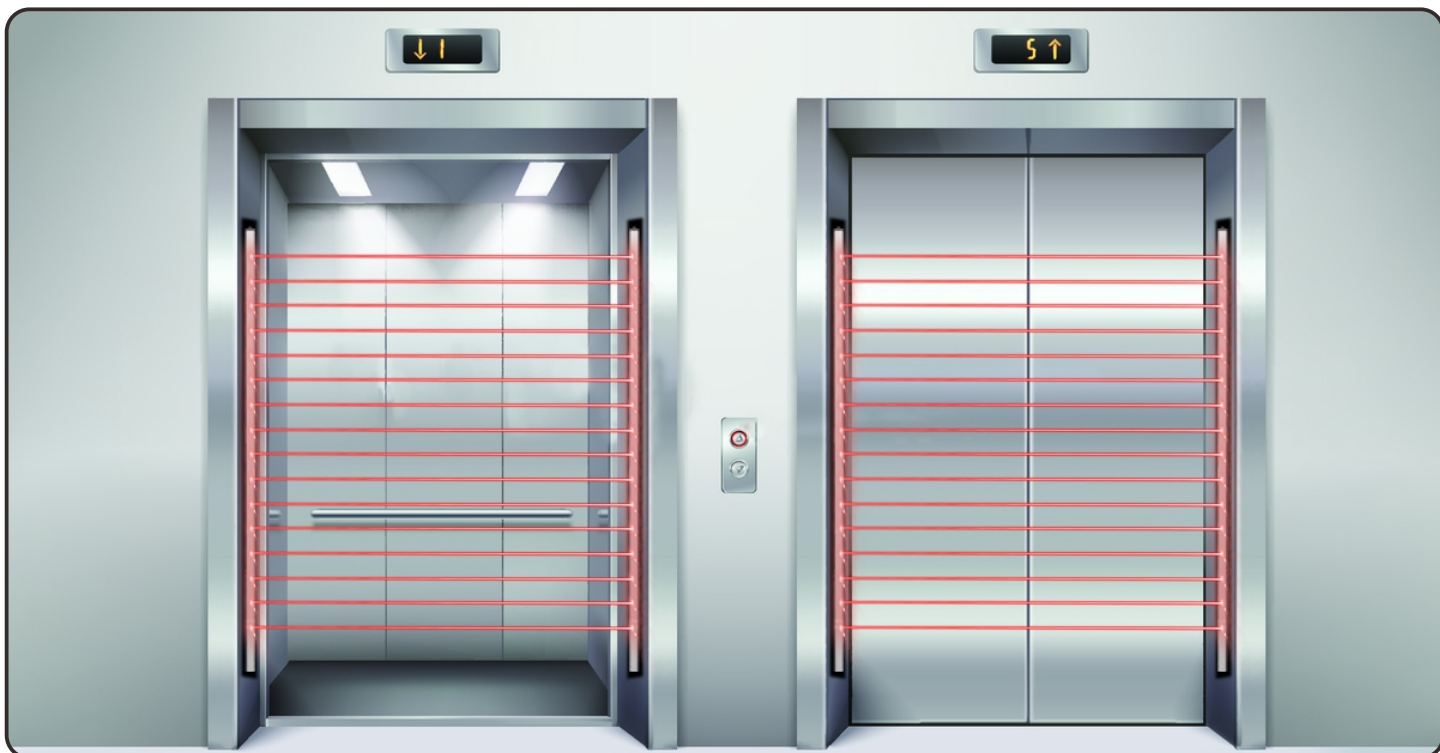
## Product Applications

Safety light curtains can be used for the safety anti-pinch (Human or object) function of fast doors and roller shutter doors. They can accurately detect people or objects, providing a signal to open the door and preventing incidents involving pinching of people or objects.
